NASA Technical Memorandum 106626 AIAA–94–2710 Army Research Laboratory Memorandum Report ARL-MR-151

Compliant Metal Enhanced Convection Cooled Reverse-Flow Annular Combustor

Prepared for the 30th Joint Propulsion Conference cosponsored by AIAA, ASME, SAE, and ASEE Indianapolis, Indiana, June 27–29, 1994

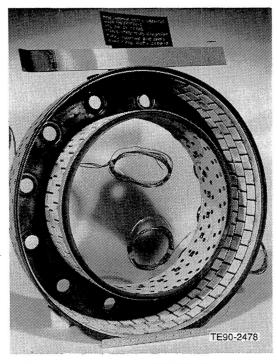
Figure 8.—CME combustor after 1989 BU1 thermal paint test.

condition is given in Figure 8. As shown, no damage was sustained to the combustor hardware, and the ceramic tiles were in place with no spalling or delamination noted. The only noticeable change, other than discoloration, from the new ceramic condition were small hairline cracks on the OTL innermost two rows of tiles. Further details can be found in Reference 3.

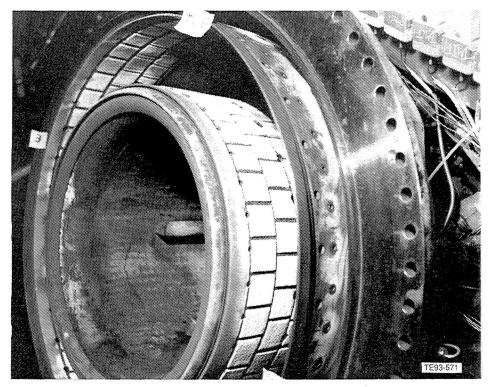
Figure 16.—CME combustor after 9/29/92 2700 °F BOT cyclic shock test—liner.

The durability of the CME cooling concept was evaluated in a series of cyclic tests. The first consisted of a 3-hr, 32 cycle thermal shock test at a maximum BOT of 2700°F (1756 K). The specific cycle is given in Figure 6. The 32 cycle test was completed without incident and inspection of the combustor and OTL revealed no apparent damage or deterioration.

Photos of the liner and OTL following the 2700°F (1756 K) BOT cyclic test are shown in Figures 16 and 17, respectively. Overall steady-state performance was consistent with other similar test points with the exception of pattern factor. Before initiation of cyclic testing, pattern factor was measured as 0.197 and increased to 0.226 following the 32nd cycle test. After comparing the BOT traces of BU-4 with BU-2, it appears that the air leak appears to have returned. Hence, a similar value of pattern factor was also obtained. The cause of the leak may be related to rig assembly or possibly mechanical distortion from the severe 3000°F (1922 K) average temperature of BU-3.

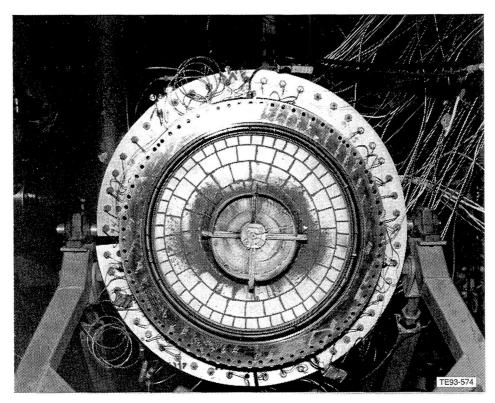
Figure 22.—CME combustor after 10/02/92 3000 °F BOT cyclic shock test—OTL.

During the 68th cycle, as fuel was increased to attain 3000°F (1922 K) BOT condition, a sudden over temperature was observed. Rig inspection revealed that the axial swirler at the No. 4 fuel nozzle position was mechanically displaced. The over temperature caused the inner liner-to-rig seal to melt, which deposited on the OTL as shown in Figure 22. In spite of the severe temperature conditions, the outer liner ceramic tiles survived relatively intact. A view of the outer liner tiles, showing discoloration and through-the-plane cracking is provided in Figure 23. On the other hand, much more damage was sustained to the inner wall tiles where a view is given in Figure 24. This was attributed to the starvation of coolant flow on the inner wall when the swirler failed. Because of the reverse-flow design, inlet air enters at the outer wall and must flow across the combustor dome before turning and entering the inner wall plenum. With the open area surrounding fuel nozzle 4, it is suspected air would preferentially enter the opening and consequently starve the inner wall of coolant air. This likely exasperated the failure of the inner seal which may have led to the type of mechanical distortion observed around the dome.

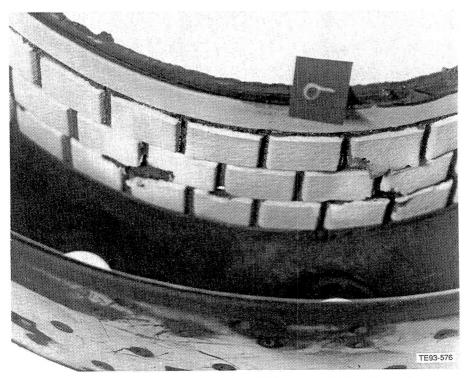
Figure 24.—CME combustor inner wall after 10/02/92 3000 °F BOT cyclic shock test.

Mechanical failure of the axial swirler during cyclic durability testing and subsequent combustor damage was an isolated incident and was unrelated to the performance of the CME wall concept.
